## Southeastern US Tornado Outbreak 21-22 January 2017

**Destruction of Albany Baptist Church in Albany, GA**

**University of Florida's Wind Hazard Damage Assessment Group**

## EXECUTIVE SUMMARY

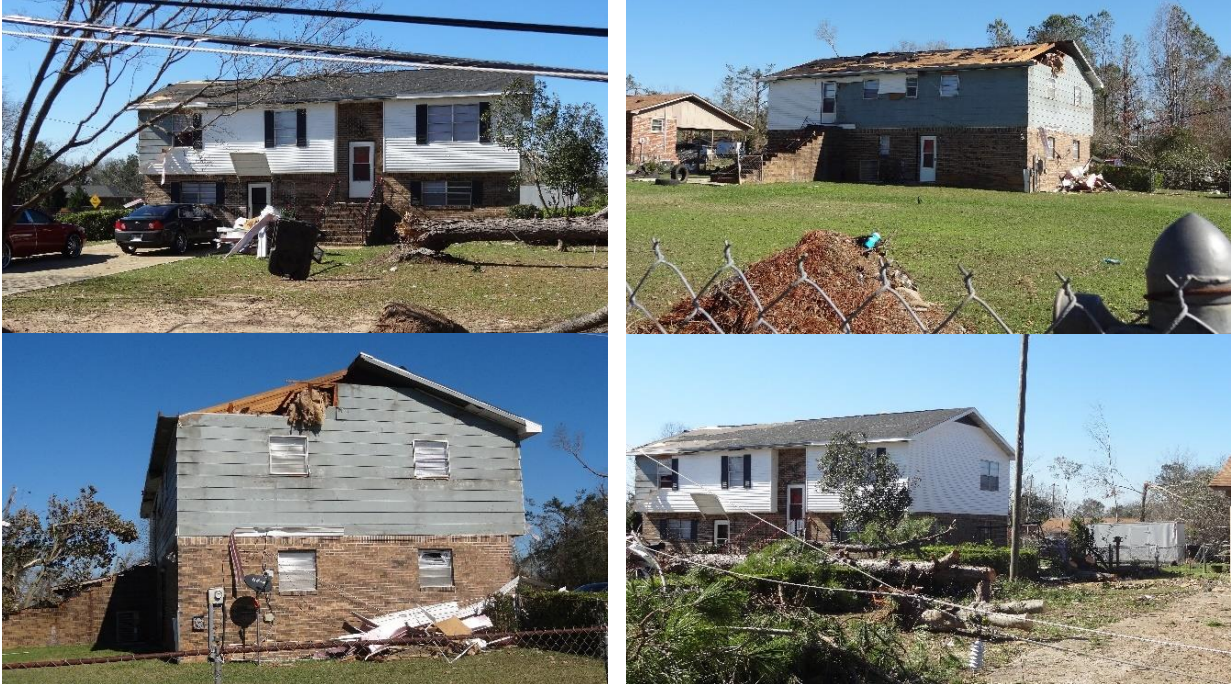
Figure 7: Damage to all four sides of a two story home located at 125 Ramsey Rd, Albany, GA.

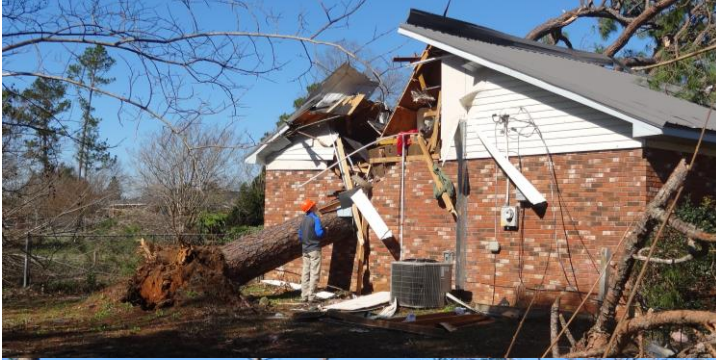
Figure 10: Uprooted pine tree cuts through a light-framed wood residential structure (Source: UF WHDAG)

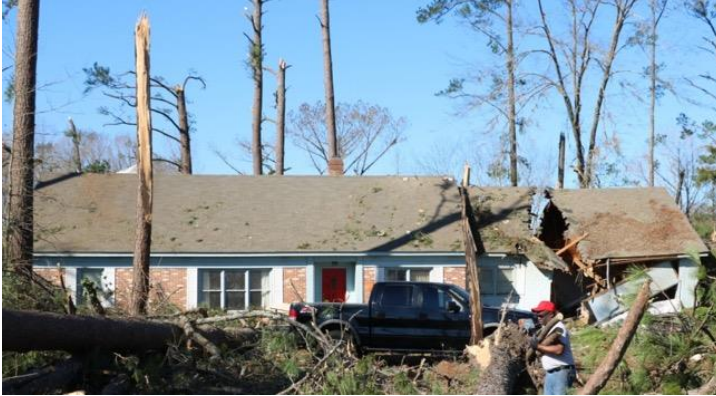
Figure 11: Light-framed wood gable roof structure located near north edge of tornado damaged by fallen tree. Only superficial damage elsewhere on structure (Source: UIUC)

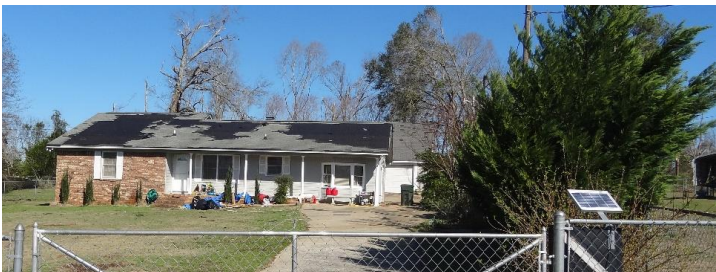
Figure 12: Some roofs had asphalt shingle roofing removed (near edge of tornado path (Source: UF WHDAG))

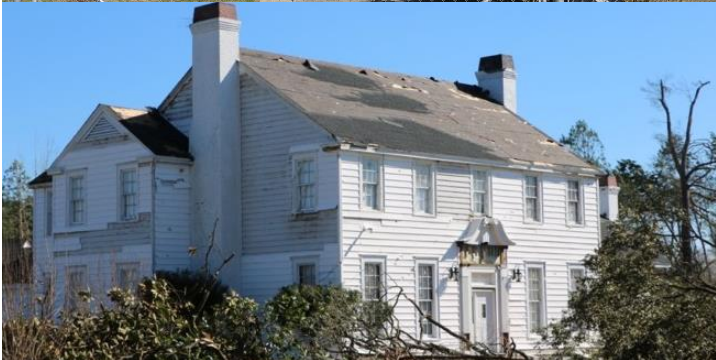
Figure 13: A 2-story structure in "Neighborhood 1" suffered asphalt shingle and siding without any obvious structural damage (Source: UIUC)

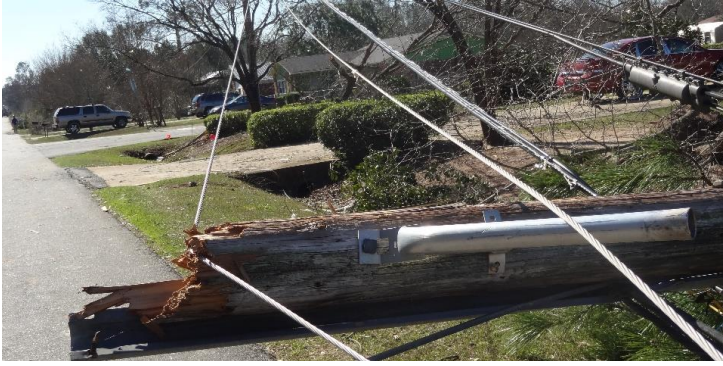
Figure 14: Downed electrical poles snapped throughout the tornado path, many observed with windborne debris. The EF Scale (DI24) gives an expected wind speed of 118 mph for this failure. (Source: UF WHDAG)

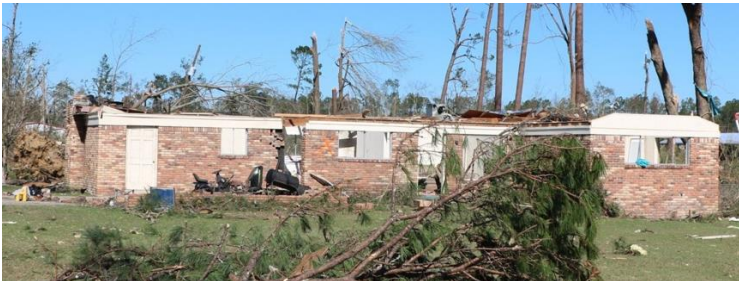
Figure 15: Several homes were totally destroyed, including this structure, west of Radiom Springs Dr. that lost its entire roof (Source: UIUC).

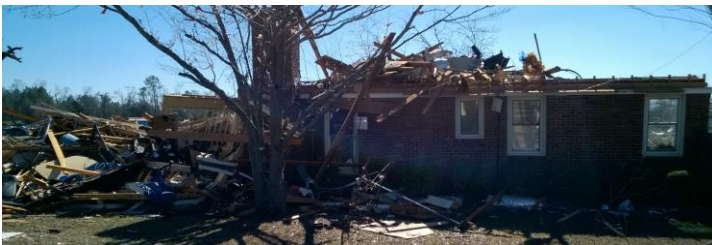
Figure 16: House located on the Sylvester Rd, adjacent to Albany Baptist Church lost its roof and several exterior walls collapsed (Source: UF WHDAG)

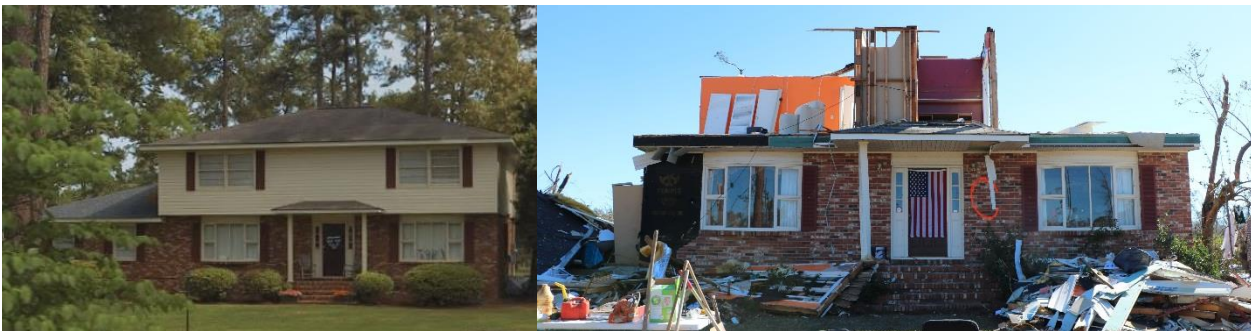
This residence east of Radium Springs Drive Figure 17 was the only residence surveyed by the UIUC team where the majority of the second floor walls had collapsed. Roughly five percent of homes surveyed had an obvious second floor. The walls of the attached garage had also collapsed. The second floor walls appear to have been anchored exclusively with nails, but the relative quality of this construction has not been determined. The residents were unharmed sheltering in the first-floor bathroom.

Figure 17: (Left) Before: Google Streetview; (Right) After: Second floor destroyed, few interior walls remaining (Source: UIUC)

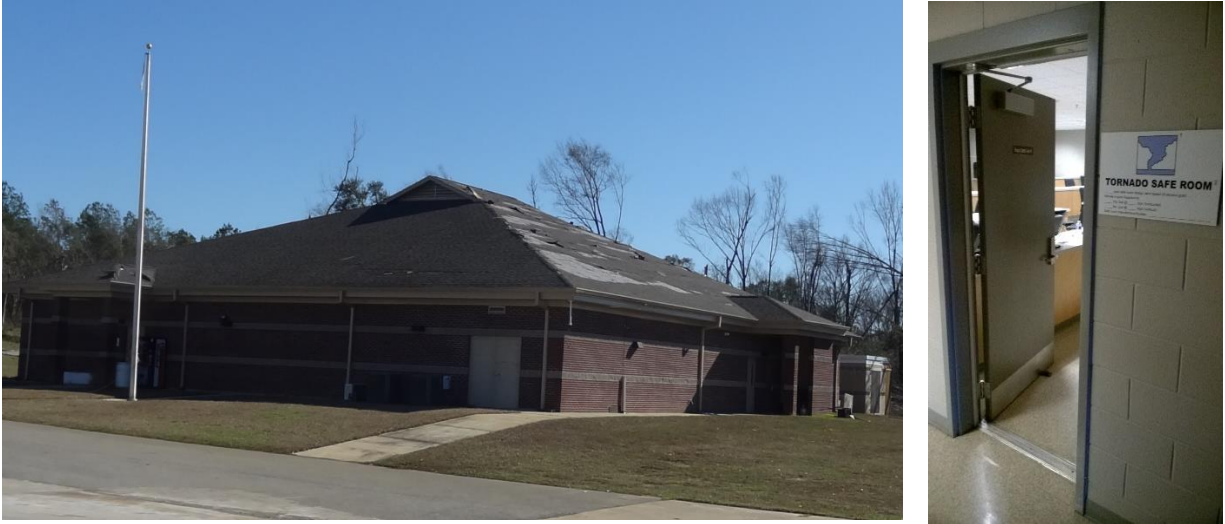
Figure 19: Training center (left) and tornado safe room within the building constructed out of reinforced CMU block with ICC approved doors and no windows (right).

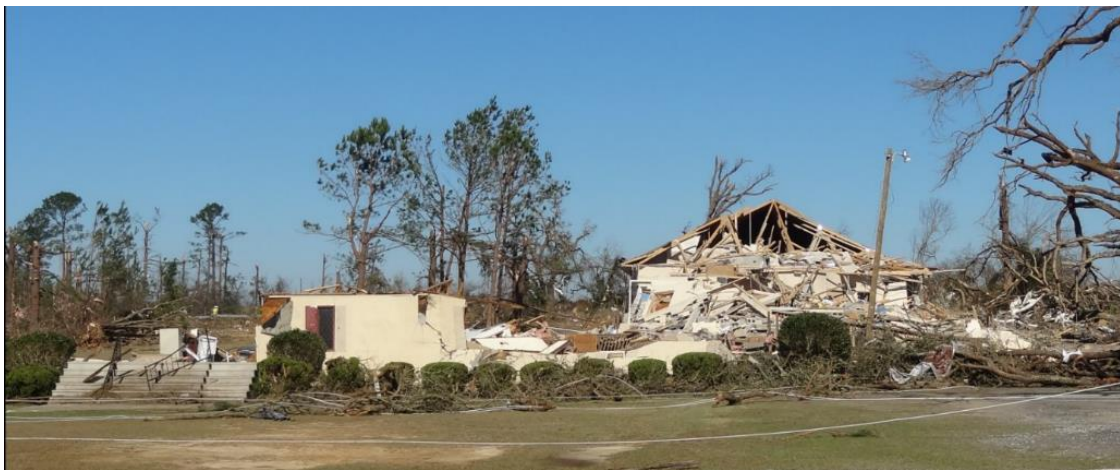
While the enhanced construction (at least relative to typical residential structures) might have enabled the church to perform better than it did, several factors may have contributed to its catastrophic failure, including the following:

- 1) The large open area in front of the church facing the road and the oncoming path of the tornado may have allowed the wind speeds interacting with the church to be higher than they would have been in a densely treed or otherwise sheltered area. Exposure effects on tornadoes are not yet well understood however, so this remains just a hypothesis.

- 2) The layout of the buildings on the property, with the older, wood-frame structure in front of the newer sanctuary, may have resulted in the older building failing first and the debris impacting the new building, breaching the envelope and increasing the loads.

- 3) The orientation of the new sanctuary was such that the gable end was in the oncoming path of the tornado. Winds coming from that direction impinging on the gable end of a structure typically produce the worst-case loading condition for the roof.

- 4) The relatively large overhang of 32 inches allows positive pressures on the underside of the overhang to add to the uplift pressures on the top of the roof surface, significantly increasing the uplift loads on the roof-to-wall connections.

Figure 21: Front view of Albany Baptist Church after the tornado. Nearly half of the new sanctuary was destroyed by the tornado. The older wood-frame sanctuary was completely destroyed except for one interior room.

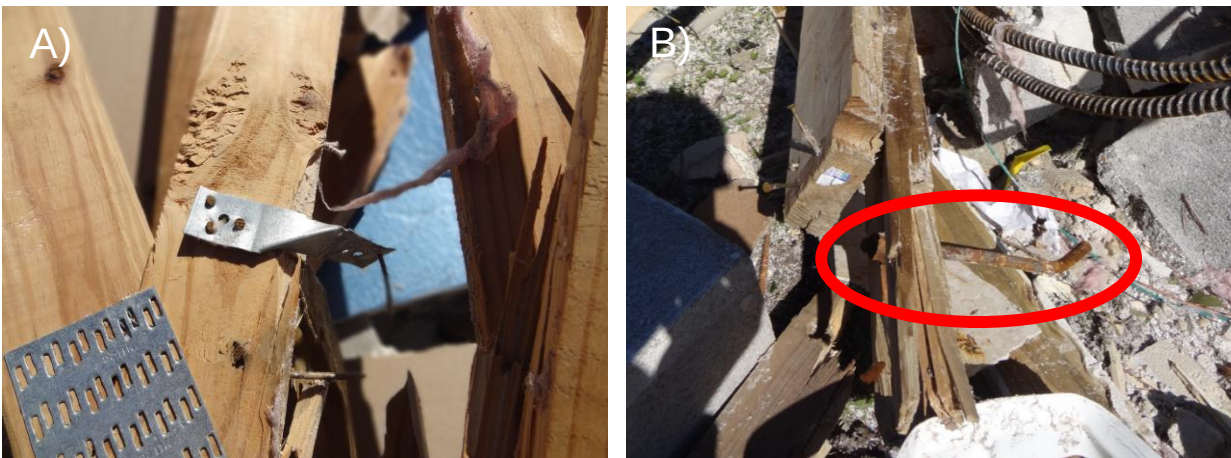
Figure 22: (C) USP RT12 hurricane tie used to attach each truss to the wall plate; (D) j-bolt with nut and washer used to fasten top plate to reinforced tie-beam along top of masonry wall.

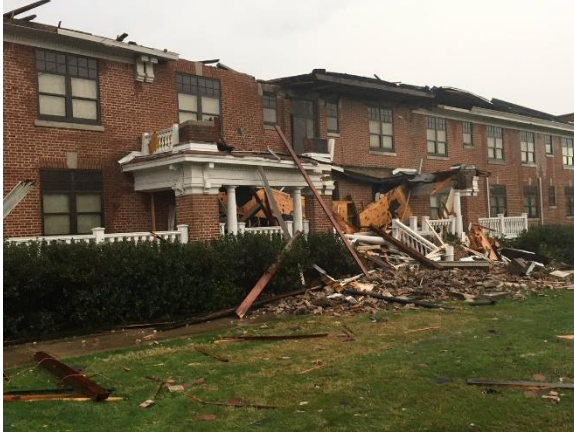
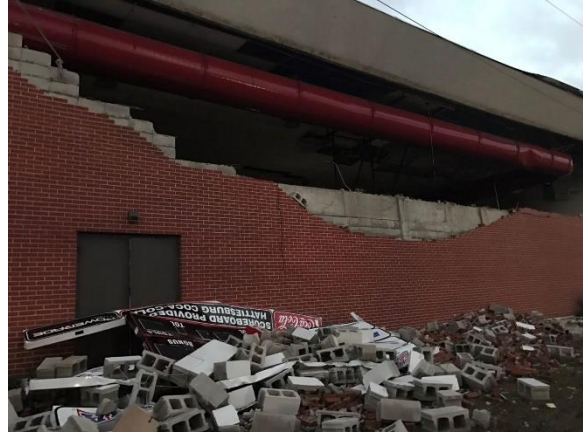
Figure 24: Damage to institutional buildings at William Carey University (Left: @[WmCareyU](#); Right: @[RyanMooreMS](#)). Note the lack of grout in-fill in a large section of the CMU wall, which crumbled under the wind loads as a result.

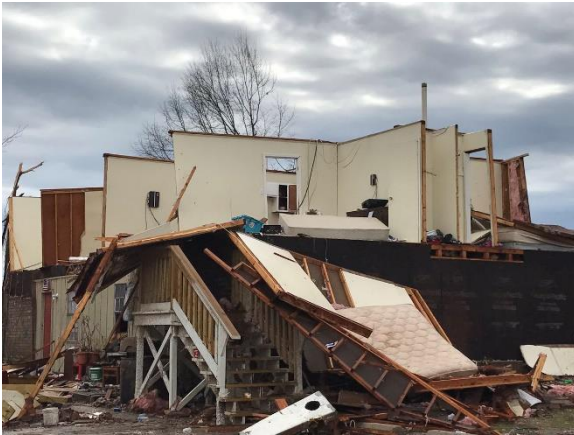
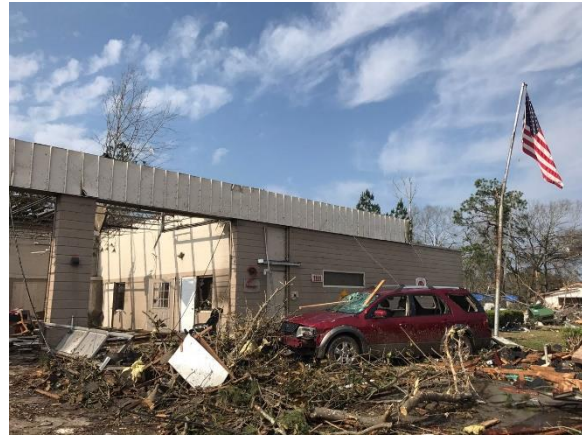
Figure 25: Damage in Hattiesburg to an apartment complex (left, by [Ryan Moore](#)) and to Fire Station 2 (right, by [Ryan Moore](#)). The large openings shown in the fire station allow wind to pressurize the interior space, enhancing wind loads on the roof system.

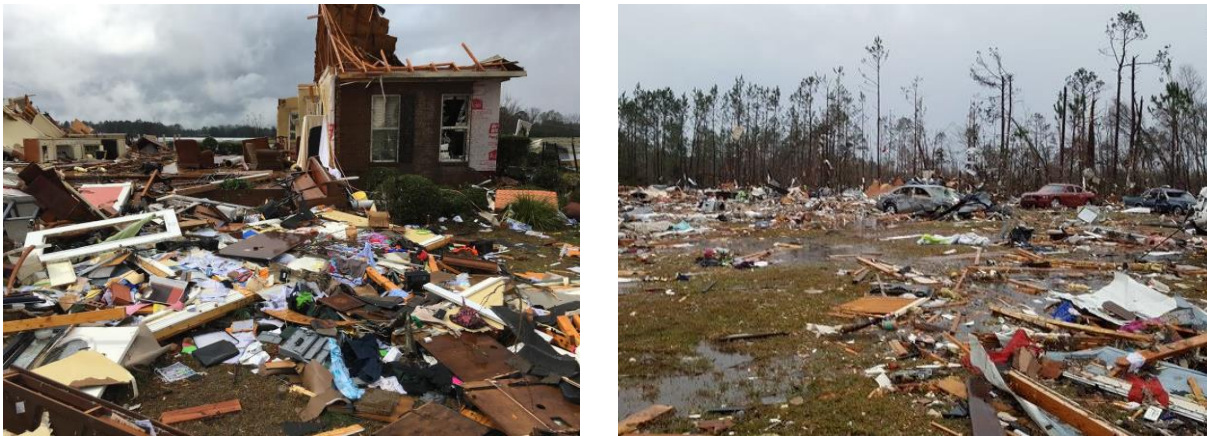
Figure 27: Damage near Adel, GA to a site built home (left, photo by [Andrew Gorton](#)), and Sunshine Acres (right, photo by [Nathaniel Maine](#)).

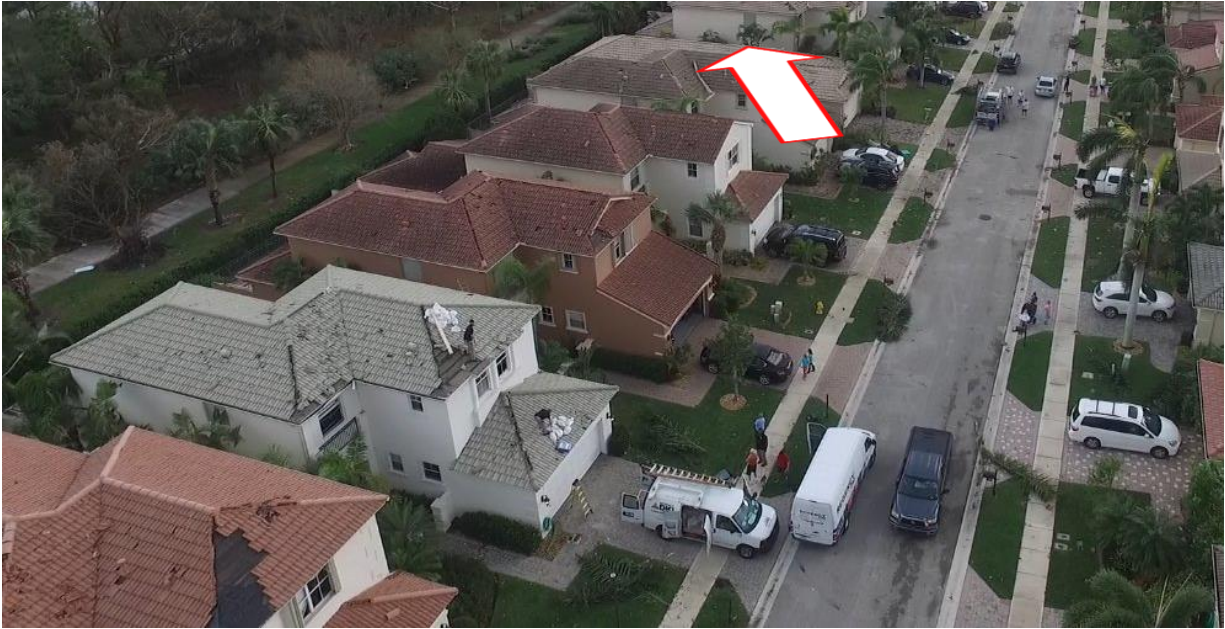
The apartments were built in 2004, after Florida adopted the statewide wind-resistant building code. In IBC 2003, the design wind speeds for this area of Florida can be interpolated as 145 mph, and further, it is

a wind-borne debris region. With an EF1 tornado having maximum wind speeds of 110 mph, the wind speeds encountered by the apartment roofs were well below design, yet a significant number of roofing tiles failed. The failures raise the question as to what performance level the building code actually provides. Was this damage acceptable, since the building did not collapse and there was no loss of life? Should the expectation be that no damage occur in a below-design level wind event? Performance expectations for code-compliant structures are not well defined, and thus the failures observed here are an interesting consideration.

Figure 30: Clay tile failure on multiple roofs in Palm Beach Gardens from the EF1 tornado. The approximate direction of tornado travel is indicated by the red/white arrow. Photo by [Michael Buczyner](#).
