# Addressing Interconnections Between the Built and Natural Environments Through Post-event Damage Surveys

## PROJECT GOAL

Characterize the interconnectedness of the built and natural environment within a given community and show how risk from tornadoes can be mitigated by improving our knowledge of these interconnections.

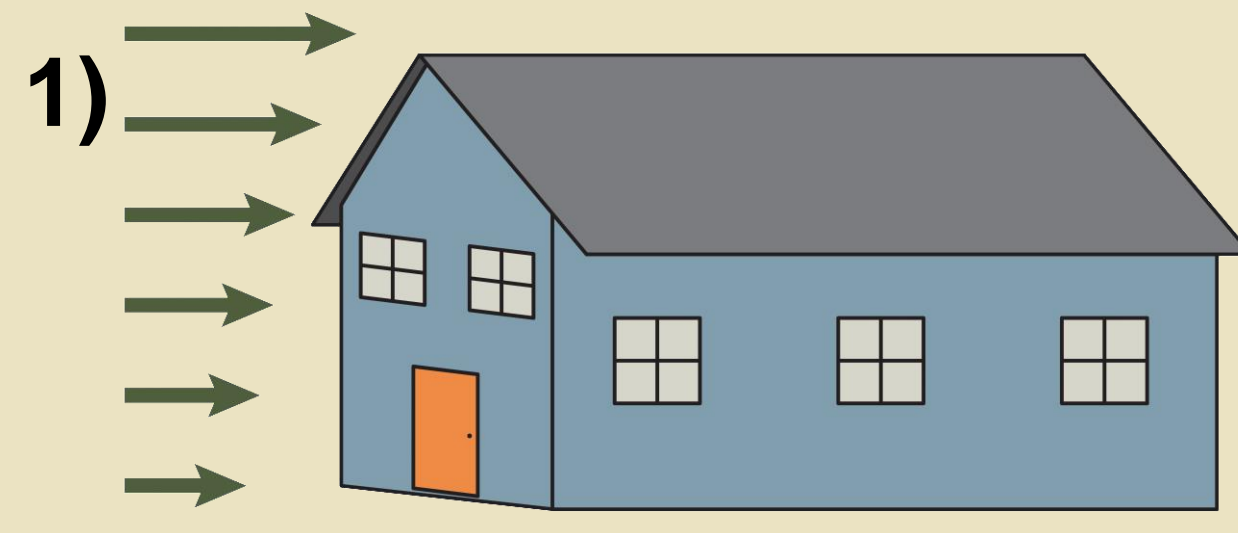
Wind Force

Debris and treefall patterns allow an estimation of the near-surface wind field using a Rankine vortex model coupled with both a tree stability model and an infrastructure fragility model that simulates debris flight.

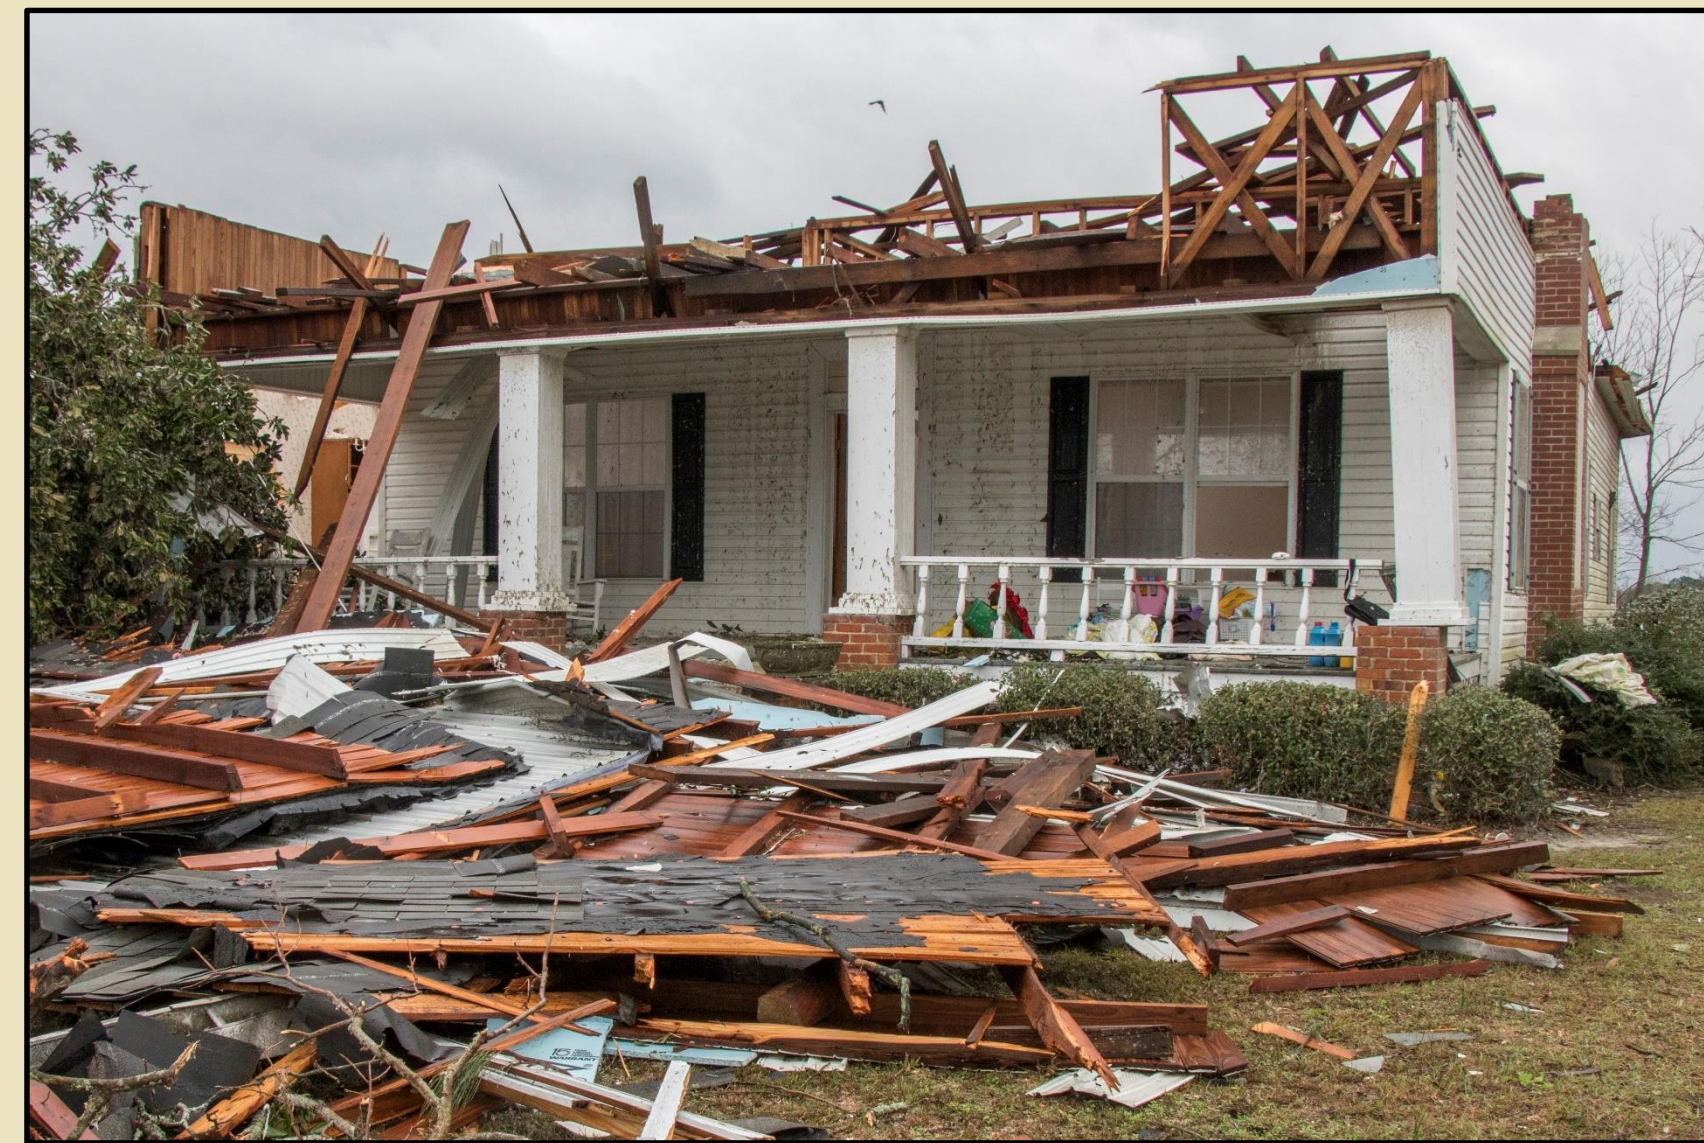
Damage to a 1.5-story residential structure, looking toward the west.

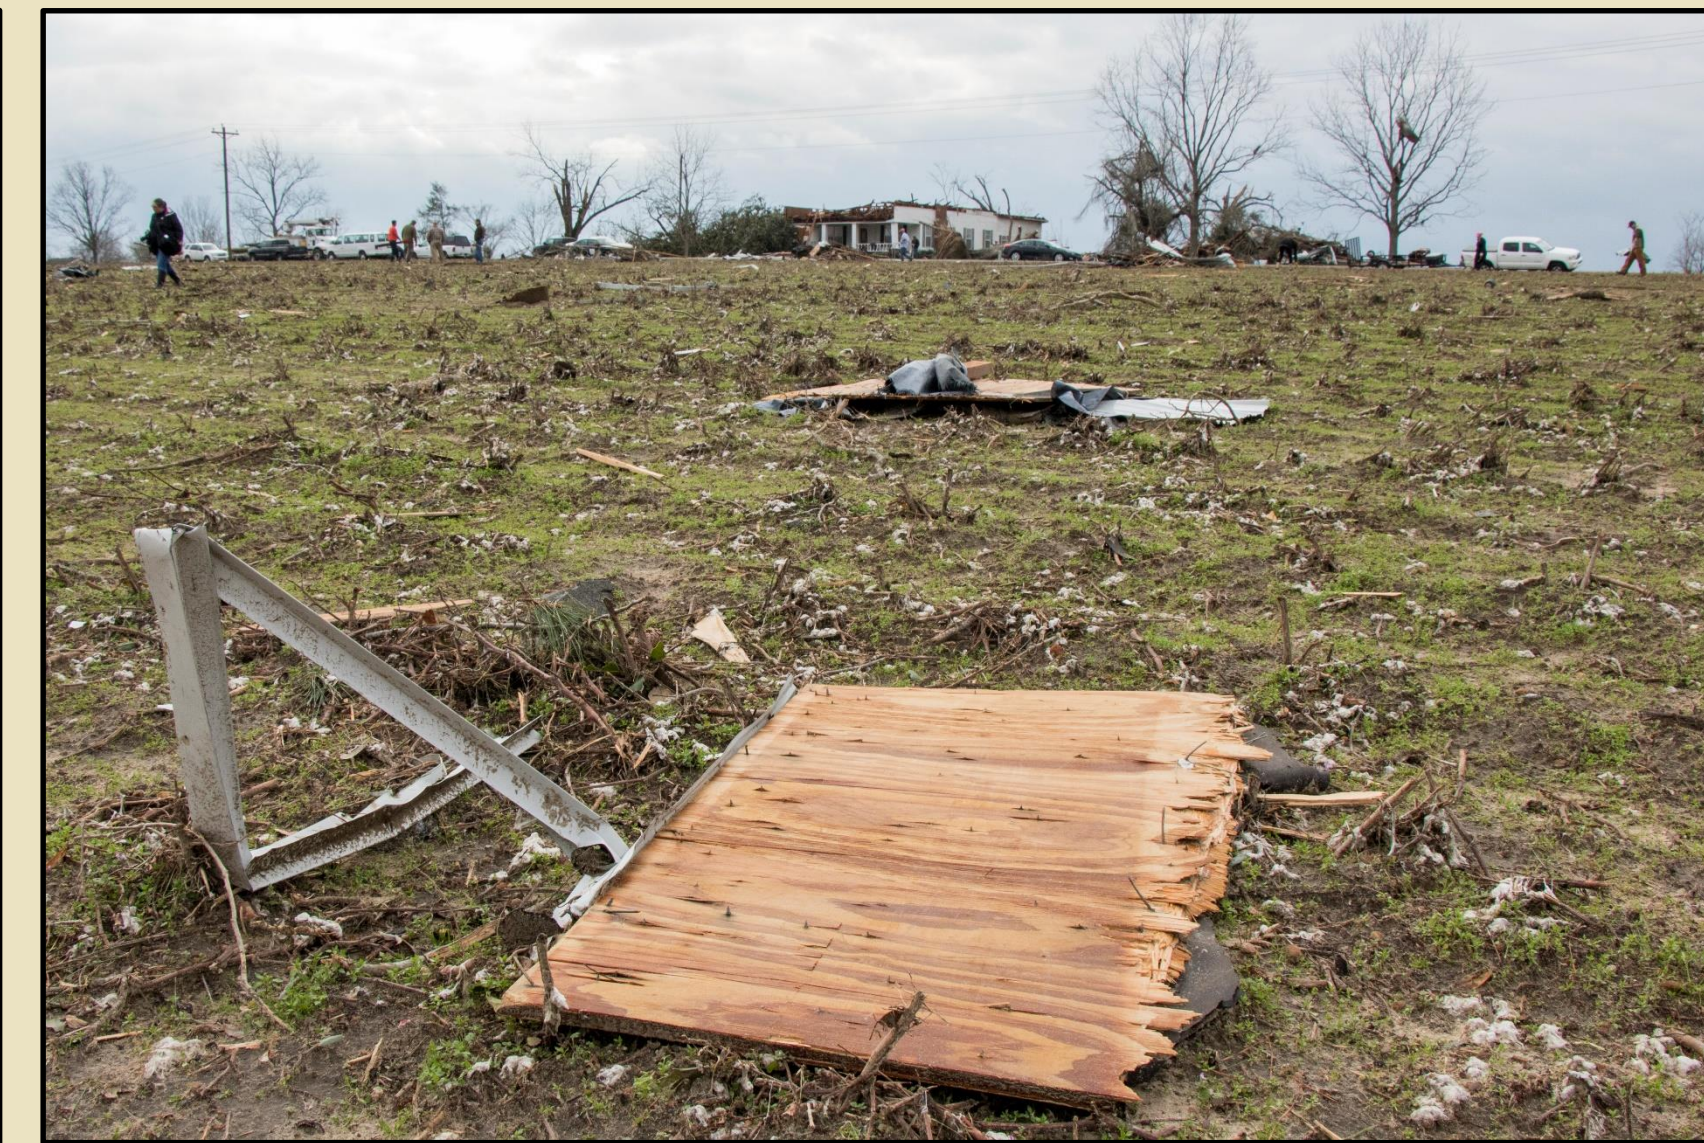
Geotagged debris photograph pointing west toward the source structure shown on the left.

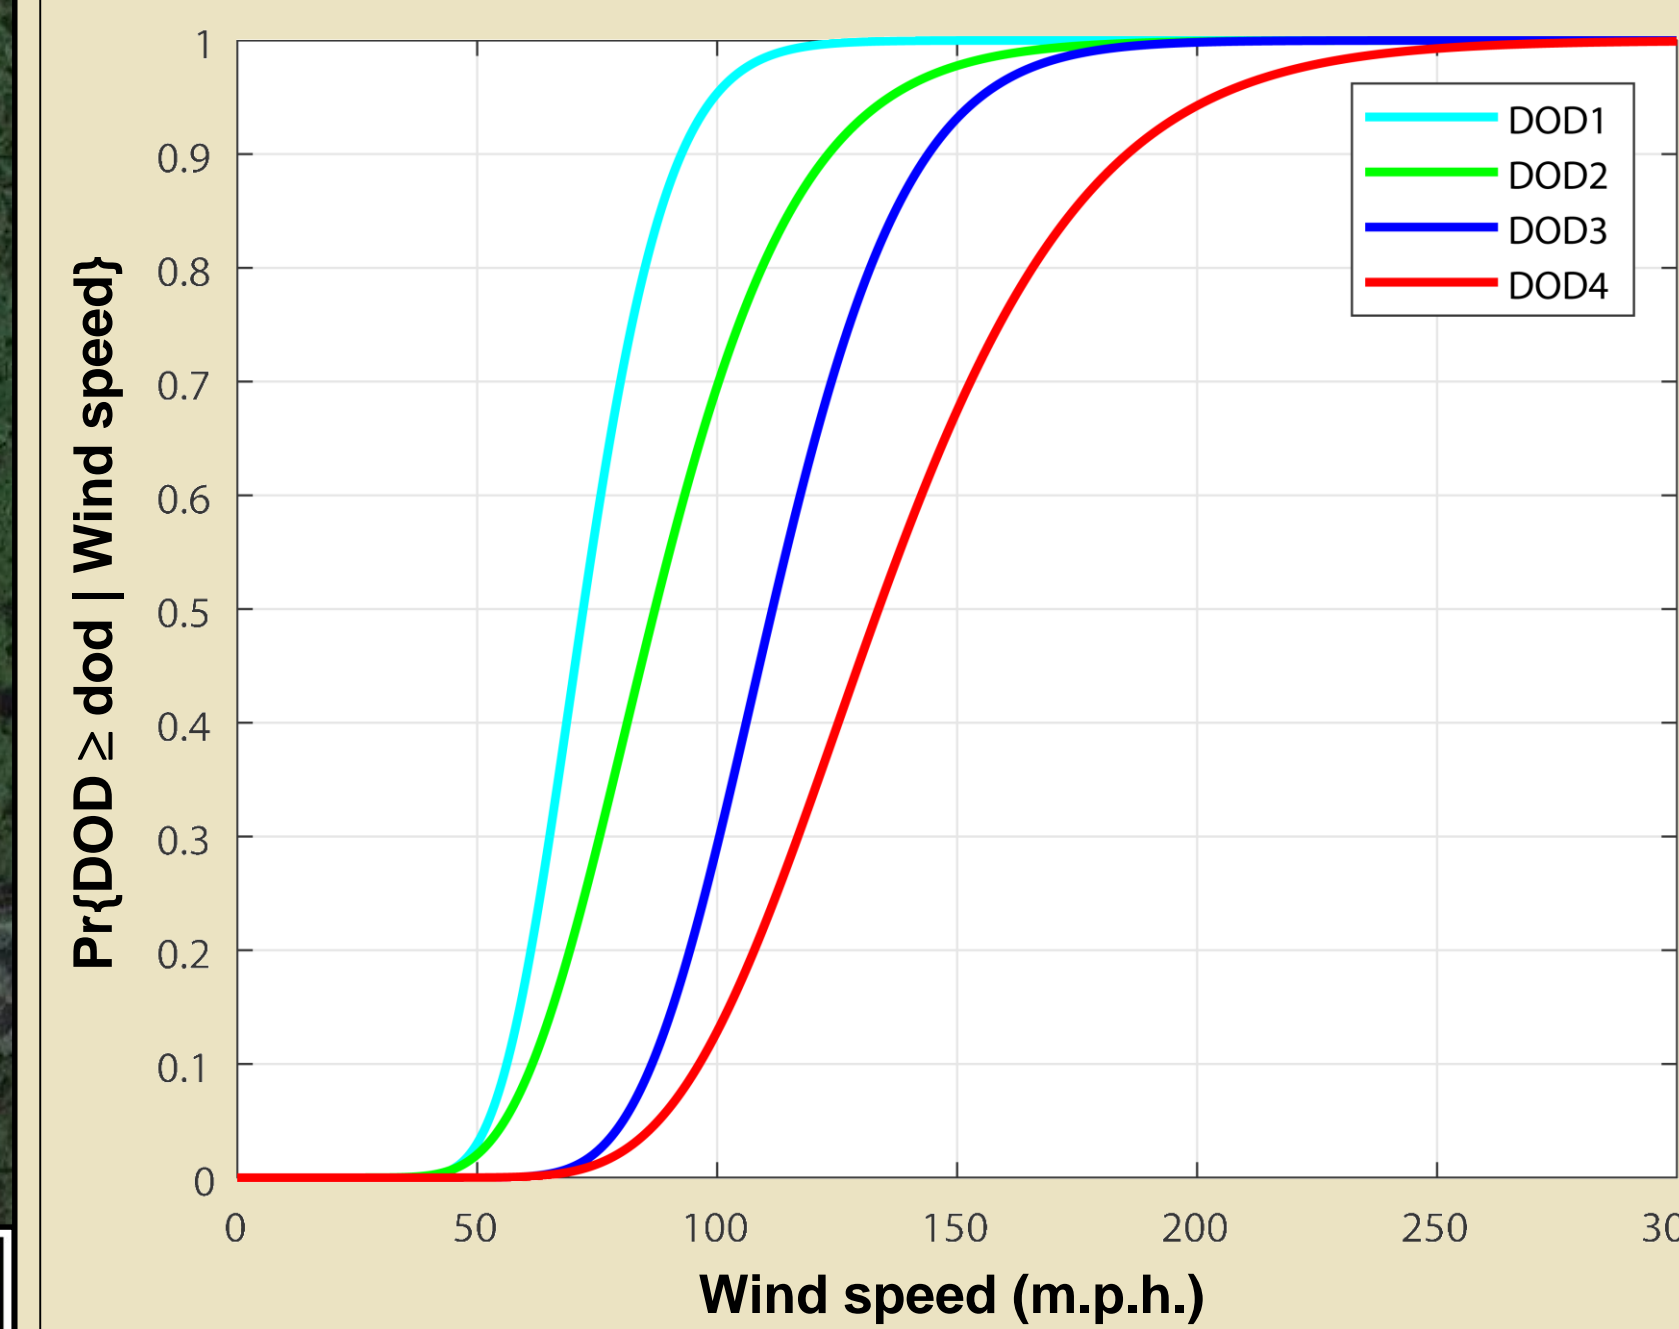
Above: Fragility curves based on the degree of damage (DOD) to residential construction on the EF scale and estimated wind speeds derived from the fall direction of trees. The abscissa gives the probability that an observed DOD equals or exceeds the DOD shown for each curve given a particular wind speed.

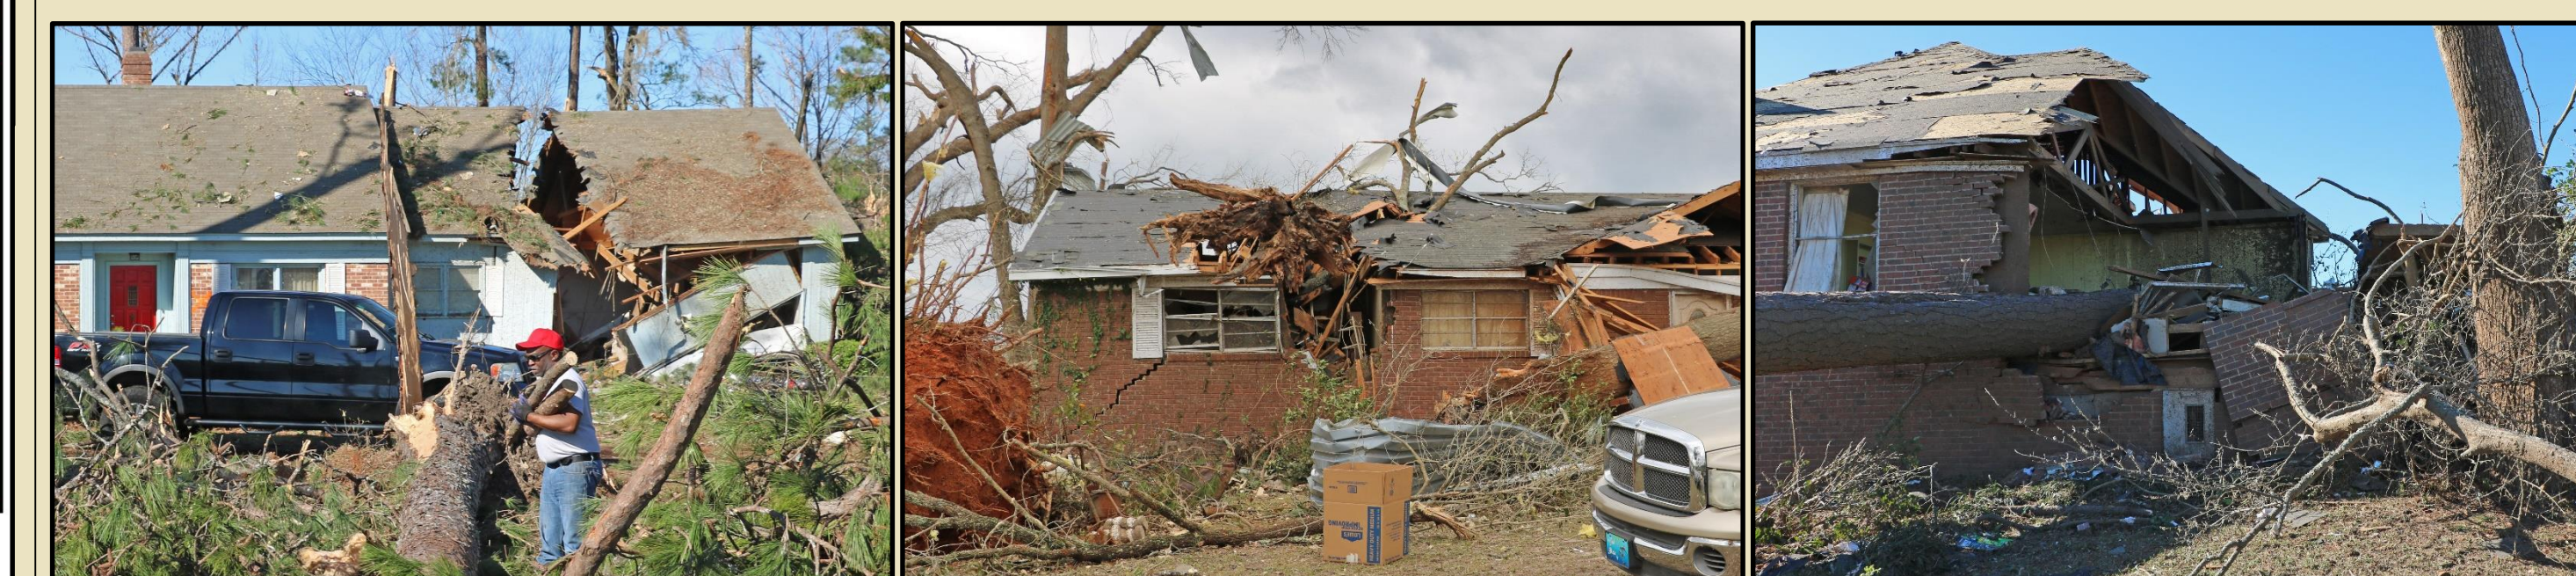
- Neighborhood within a mature loblolly pine forest
- Significant structural damage from treefall rather than directly from wind

Residential damage following the Albany, GA tornado highlights significant wind-induced tree damage coupled with minor direct wind damage.
