## Southeastern US Tornado Outbreak 21-22 January 2017

**Destruction of Albany Baptist Church in Albany, GA**

**University of Florida's Wind Hazard Damage Assessment Group**

## EXECUTIVE SUMMARY

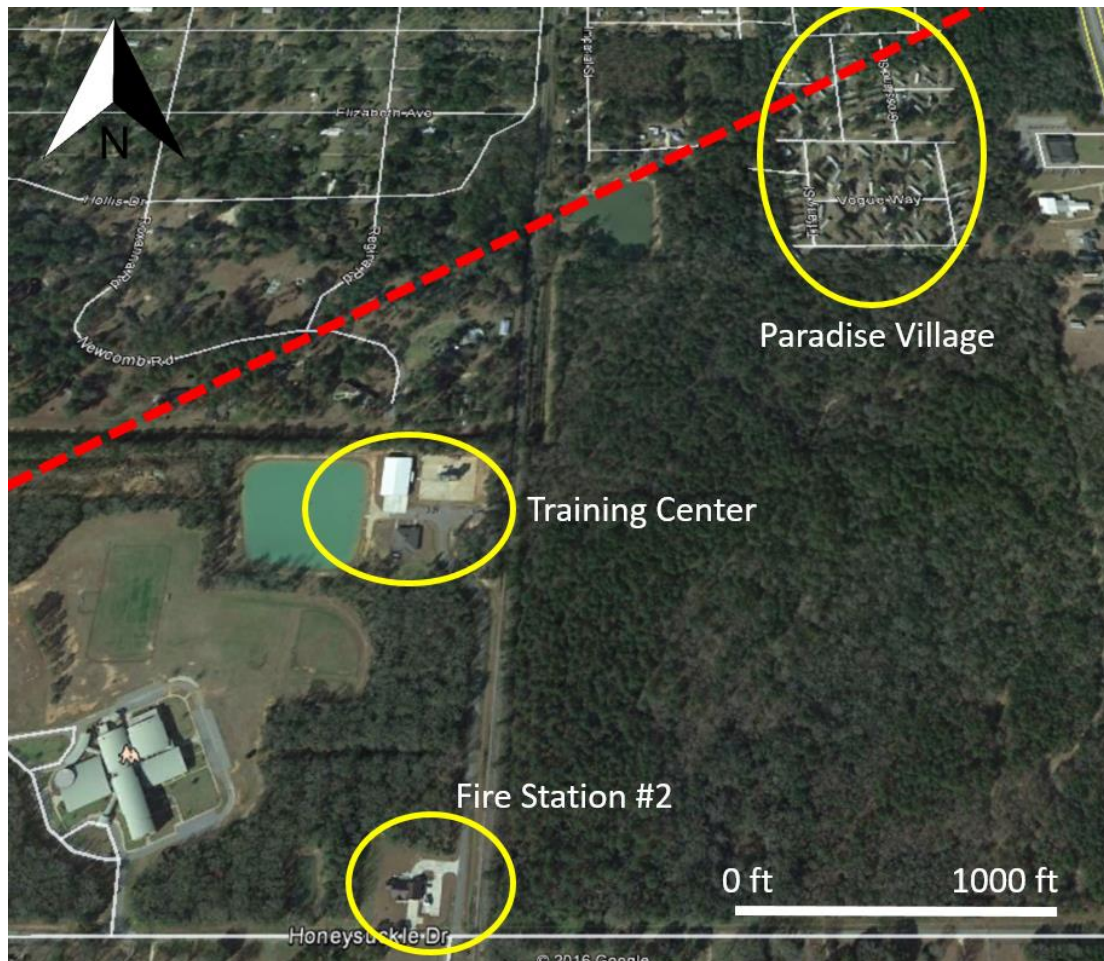
Figure 18: Location of Albany Fire Station #2 and Training Center in relation to the Paradise Village subdivision. An approximation of the tornado centerline is shown by the red dashed line.

Albany Fire Station #2 is located at 115 Honeysuckle Dr., on the right side of the tornado centerline just southeast of the Paradise Village mobile home park where three fatalities occurred. The training center contains a designated ICC500 tornado shelter within the main building. Three fire station personnel sheltered there during the tornado. The shelter itself, a separate room inside a larger building, did not sustain any damage, but the exterior of the building housing the shelter did sustain roof cover loss. In addition, a warehouse on the same site had one of four rolling doors collapse inward, with the resulting pressurization causing the corrugated metal panels on the back side of the building to rip off the supporting metal frame structure. Further analysis is being conducted to estimate failure wind speeds from these observations.

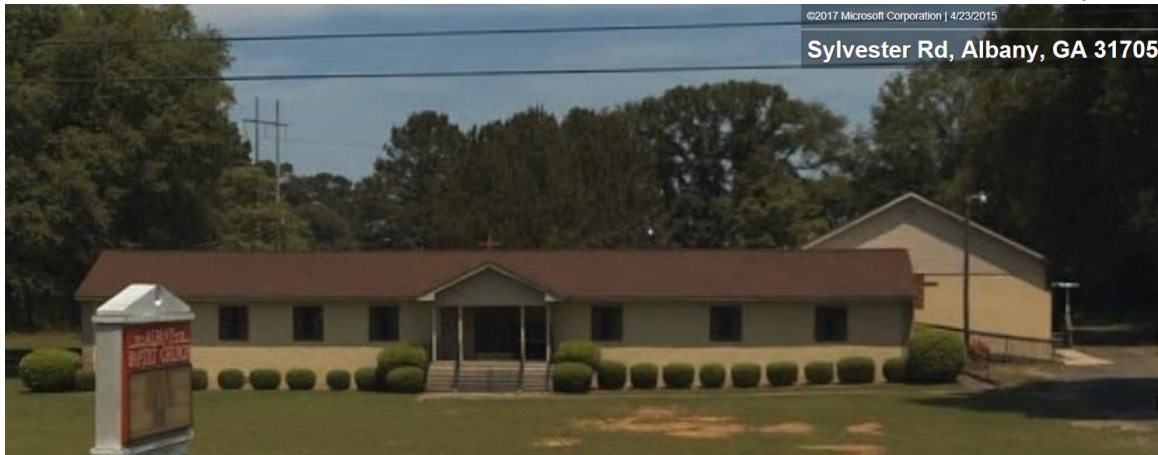
Figure 20: Front view of Albany Baptist Church before the tornado using Bing Streetside.

Albany Baptist Church is located at 3515 Sylvester Rd consisting of two main buildings, a fellowship hall which used to be the sanctuary, and a new sanctuary was built in 2002. Figure 20 and Figure 21 show before and after views of the church. The old sanctuary, is in the foreground and it is light-framed wood structure. The building in the background is the new sanctuary, and it is a reinforced concrete masonry units (CMU) block exterior walls with metal plate wood truss roof structure. The CMU wall had grouted cells, with rebar, at 8 ft on center. A wood top plate was fastened to the tie beam along the top of the wall with  $\frac{1}{2}$ -inch j-bolts at 4 ft on center. Trusses were spaced at 2 ft on center with a 32 inch overhang, and were fastened to the wood top plate using USP RT12 connectors with (3) 8d nails in each leg of the connector. USP gives an allowable wind uplift capacity of these connectors as 355 lbs. Further analysis is being conducted to estimate the wind speed necessary to cause the observed failures.

While the enhanced construction (at least relative to typical residential structures) might have enabled the church to perform better than it did, several factors may have contributed to its catastrophic failure, including the following:

- 2) The layout of the buildings on the property, with the older, wood-frame structure in front of the newer sanctuary, may have resulted in the older building failing first and the debris impacting the new building, breaching the envelope and increasing the loads.

- 3) The orientation of the new sanctuary was such that the gable end was in the oncoming path of the tornado. Winds coming from that direction impinging on the gable end of a structure typically produce the worst-case loading condition for the roof.

- 4) The relatively large overhang of 32 inches allows positive pressures on the underside of the overhang to add to the uplift pressures on the top of the roof surface, significantly increasing the uplift loads on the roof-to-wall connections.

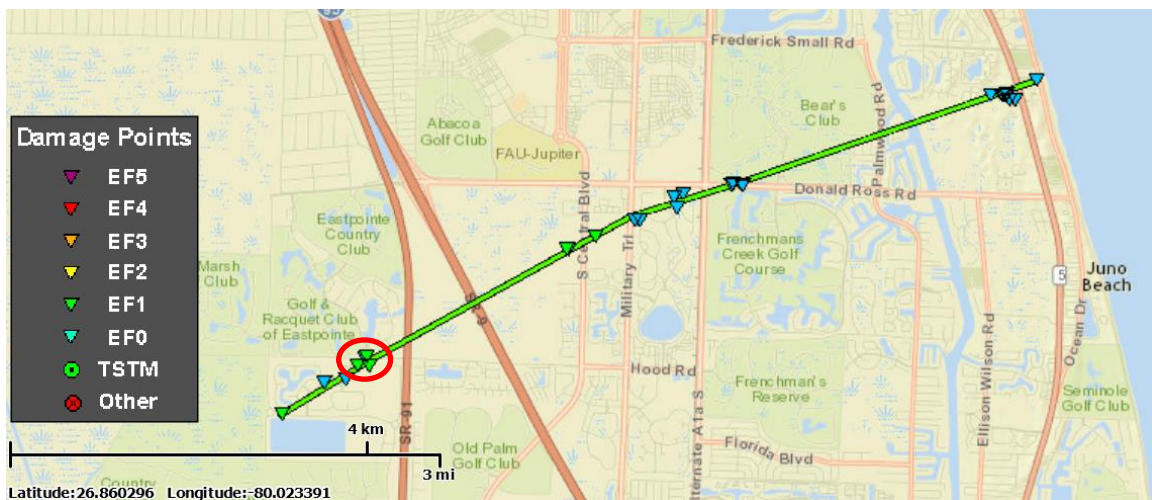
Several tornadoes occurred in south Florida in the evening of 22 January as the squall line moved eastward across the Florida peninsula. Figure 28 shows the damage paths as confirmed by the NWS Miami office. Each tornado was rated EF1, with maximum wind speeds estimated at less than 110 mph. Damage mostly consisted of broken tree branches and minor roof covering loss to residential structures. Of interest though was roof cover damage to a set of apartments in Palm Beach Gardens (just north of West Palm Beach). The entire damage path is shown in Figure 29, with the location of the apartments highlighted. A view of the apartments, looking east, is shown in Figure 30.

The apartments were built in 2004, after Florida adopted the statewide wind-resistant building code. In IBC 2003, the design wind speeds for this area of Florida can be interpolated as 145 mph, and further, it is

a wind-borne debris region. With an EF1 tornado having maximum wind speeds of 110 mph, the wind speeds encountered by the apartment roofs were well below design, yet a significant number of roofing tiles failed. The failures raise the question as to what performance level the building code actually provides. Was this damage acceptable, since the building did not collapse and there was no loss of life? Should the expectation be that no damage occur in a below-design level wind event? Performance expectations for code-compliant structures are not well defined, and thus the failures observed here are an interesting consideration.

Figure 29: Damage path from EF1 tornado in Palm Beach Gardens, FL. Map taken from the NWS Damage Assessment Toolkit. Location of apartments of interest indicated by red circle.
